Subject: RE: Gold King Mine Spill - brief background and initial EPA Region 9 response (internal - do

Subject: Gold King Mine Spill - brief background and initial EPA Region 9 response (internal -

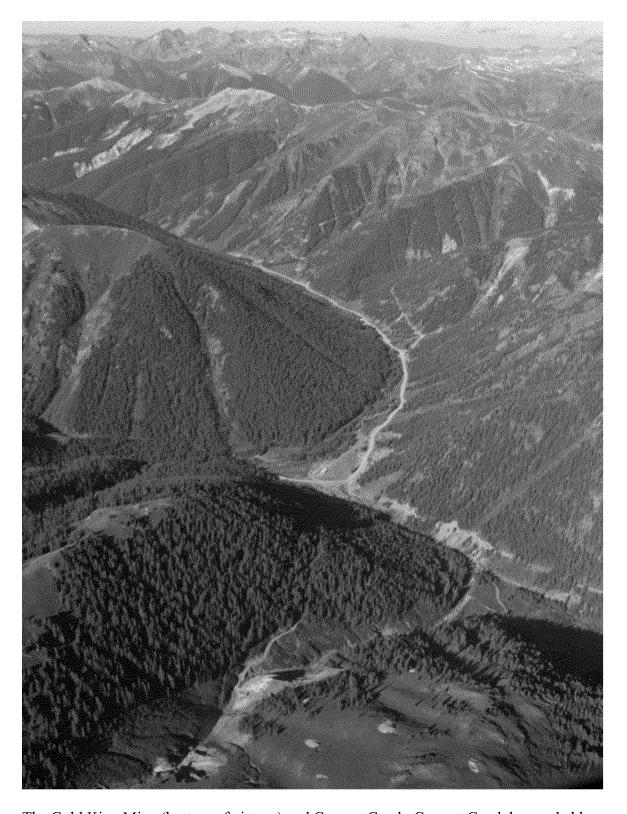
The Gold King Mine (bottom of picture) and Cement Creek. Cement Creek has probably never supported fish, and even before the spill had a pH level of about 3.5, on par with Coca-Cola.

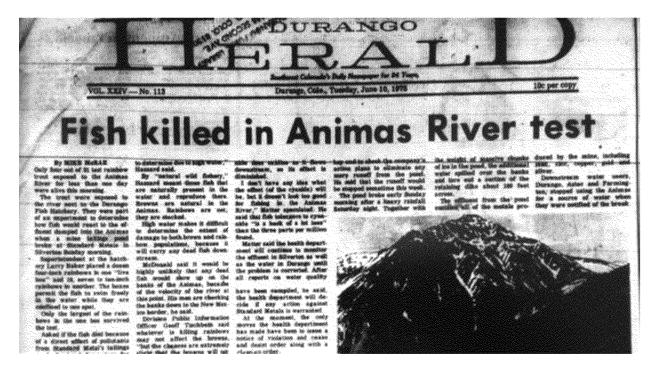
- This isn't the first time that something like this has happened, nor is it the worst: In June of 1975, a huge tailings pile on the banks of the Animas River northeast of Silverton was breached, dumping tens of thousands of gallons of water, along with 50,000 tons of heavy-metal-loaded tailings into the Animas. For 100 miles downstream, the river "looked like aluminum paint," according to a *Durango Herald* reporter at the time; fish placed in a cage in the water in Durango all died within 24 hours. It was just one of many breaches of various magnitude. Just a decade before, the same tailings pile was found to be spilling cyanide-laced water into the river.

A 1975 tailings pile breach just above Silverton sullied the Animas River for 100 miles downstream, turning the water the color of " aluminum paint" and killing fish.
